Case 33 – A Problem with Teflon Insulation

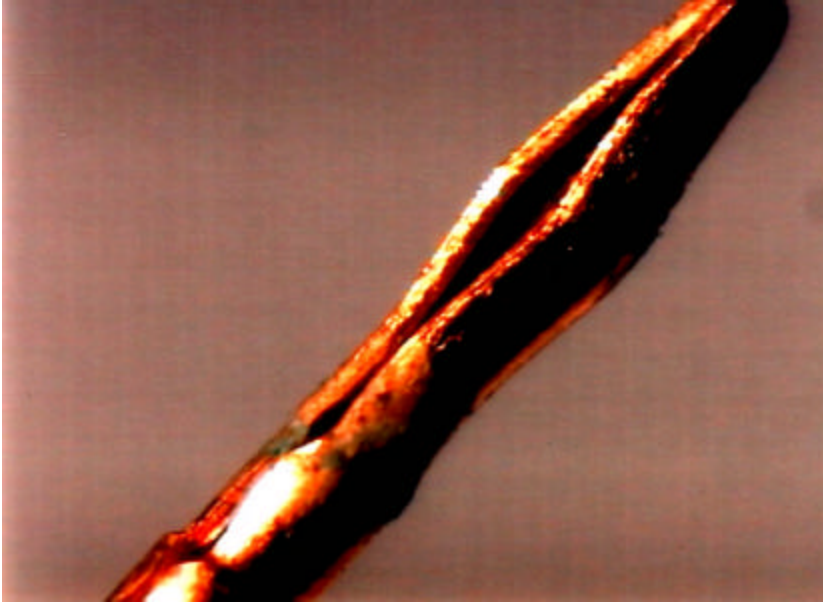
A military customer of these harness assemblies noted corrosion on the connector shells and on the pins of the plastic connectors. A film was noted on the surface of the plastic backshells. Corrosion was noted on gold crimped pins (see photo 1) which had not yet been installed into a connector. The corrosion appeared much more frequently on the white Teflon wires than for colored Teflon wires. The storage environment was 80°F and the bags were heat sealed. No electrical potential existed at any time.

We examined many different samples using ion chromatography. Chart 1 shows the levels found, concentrating on fluoride. We were able to correlate the corrosion to high levels of fluoride. Fluoride levels on corroded backshells often exceeded 50-75 micrograms per square inch. In areas where no corrosion occurred, the fluoride levels were low. Other residues, like chloride and sulfate, were also present, but they did not appear to contribute to this problem. We concluded that there were two sources for the elevated fluoride: the polyethylene bags and undercured Teflon (a fluoropolymer) wire. SEM/EDX analysis also showed the presence of silica on the corroded surfaces. The undercured Teflon outgassed fluoride over time. The silica-based slip agent of the polyethylene bags assisted in the transfer of the fluoride to the corroded parts. It is unknown why the polyethylene bags had such a high level of fluoride.

Photo 1: Corroded Gold Pin

Fluoride is one of the most electroactive residues known, and is much more corrosive than chloride. The manufacturer began to experiment with baking (1-12 hours @ 200°F) the Teflon wire to complete the cure. The longer bake time dramatically reduced the amount of fluoride. The manufacturer changed polyethylene bag suppliers and the new bags had no detectable level of fluoride. The manufacturer also went to great lengths to investigate the problem, worked with customers to alert them to the potential corrosion, and worked to determine a cure.

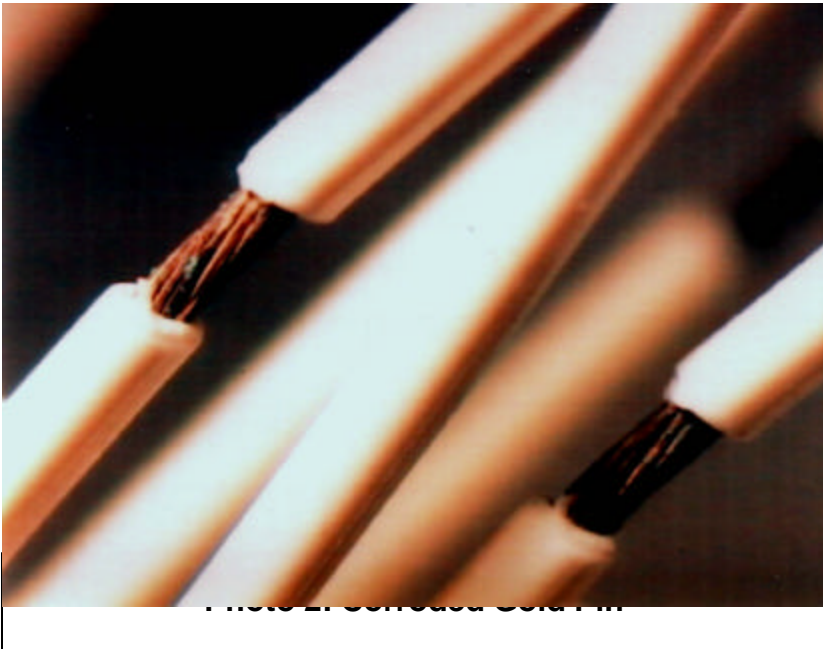
We examined several of the various kinds of wires. Photos 2 and 3 show the corrosion present on the wire at points under the insulation. The corroded areas had not been previously exposed to the outside environment.

Photo 2: Corrosion Under Teflon Insulation

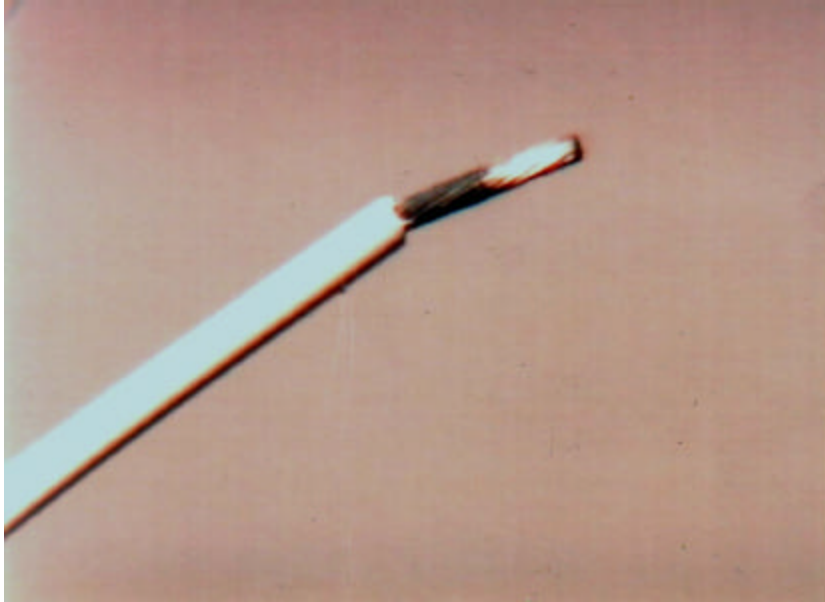
Photo 3: Corrosion Under Wire

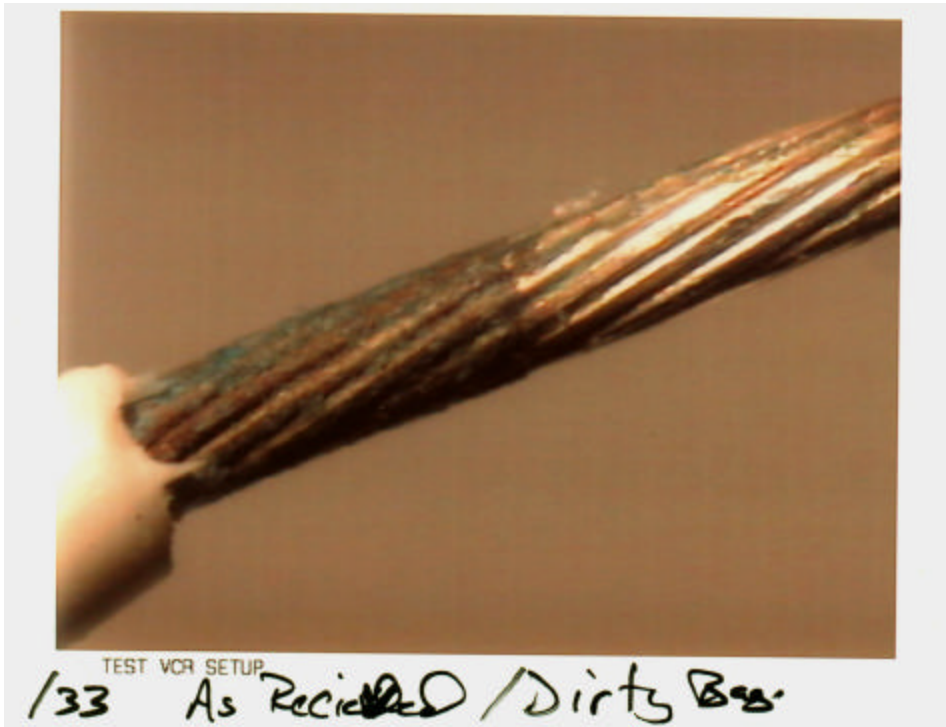
Photo 4: Closeup of Photo 3
