Terminal Block Manufacturing Residue Issues

Do manufacturing residues, specifically ionic residues, have an affect on terminal blocks that can impact electronic product quality? As a failure analysis lab we have seen problems where corrosion on the terminal blocks was affecting product performance. The following is summary of an analysis for a client who had galvanic corrosion on terminal block assemblies that had to be replaced. The goal was to determine the root cause and develop a corrective action plan.

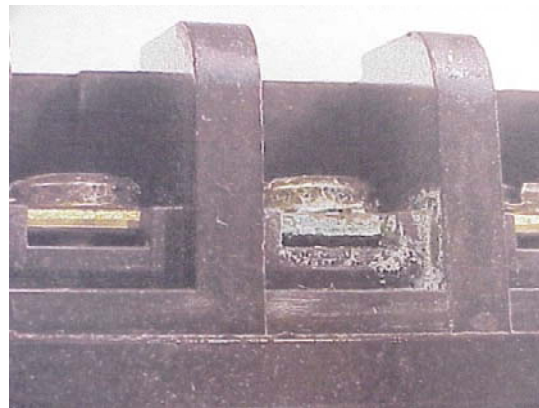
Within a month 70% of the assemblies were seeing corrosion of the terminal block brass and screw metalization. The boards showed no other sign of corrosion or visible flux residues. All brass contacts showed green and white corrosion on one or more of the terminal blocks.

1. What caused the heavy green corrosion?
High levels of chloride trapped inside the cup of the terminal block from the wash step. The level of water that was trapped in the terminal block varied greatly and did not completely air dry during the overnight open storage.

3. How did they corrode without any power applied?
The corrosion only occurred on the terminal block metal surfaces themselves and not on the board or between leads. This is because a galvanic cell was created between two dissimilar metals (the brass and the tin plated screw) and the wash water. This galvanic cell creates a small electrical charge through the solution when mixed with a strong acid, such as the chloride, which will attack the metal surfaces.

8. What can be done to salvage the boards?
Replace the already corroded terminal blocks and properly clean the boards to chloride levels below 4.5 ug/in².

Do not wash terminal blocks on assemblies. Attach after assembly and cleaning of the circuit boards or assemble with no-clean flux.

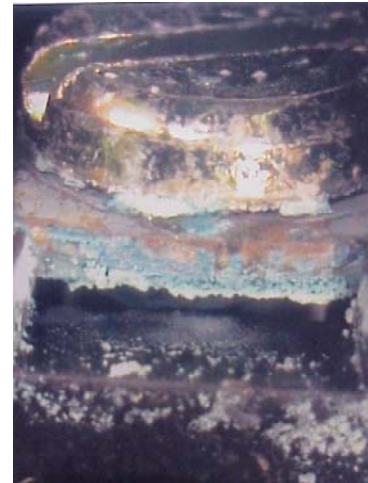
6. Can the corroded terminal blocks be salvaged?
No. The oxidation and corrosion of the surface cannot be recovered.
7. Is the white residue on the surface of the brass a problem?
No. This is the reaction of the tap water and the galvanic cell and does not have an insulative layer. It lacks the corrosive acid to attack the surface to a great depth. It can be easily removed with proper cleaning.
