Escape Artist: On a Flat Note - Part 2

Design changes involving a standoff allow for flux trapped under PQFN to volatilize and escape
Terry Munson, Foresite Inc.

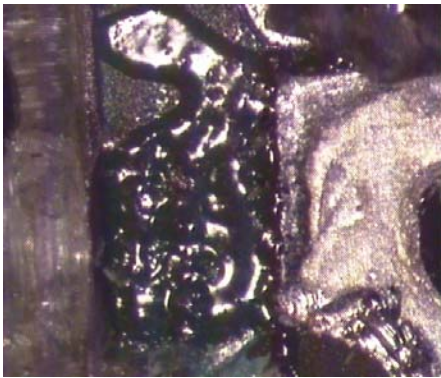
Assembly under pqfn area before cleaning:
120 $\mu\text{g} / \text{in}^2$ WOA

Our ion chromatography findings were very encouraging, but we still had to determine whether or not the assemblies built with the old manufacturing process with entrapped flux under PQFN components were recoverable. Foresite was able to develop a localized recovery cleaning protocol to clean only the PQFN area of the contaminated assemblies. Through the use of localized deionized steam cleaning with a good saponifier, we were able to effectively remove the harmful weak organic acid residues and goeey flux that was entrapped underneath the PQFN components. Based on a follow-up proof of cleaning investigation, it was found that this cleaning protocol produced results well below our recommended ionic residue limits for reliable field performance of a no-clean assembly. (See before & after photos)

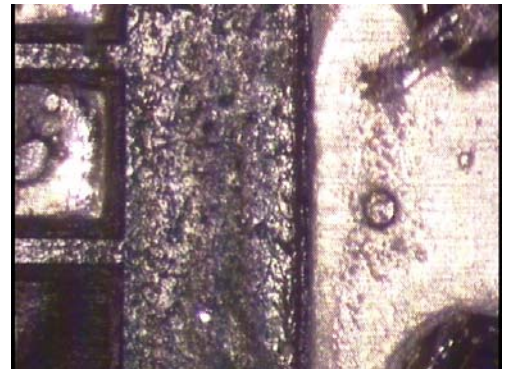
Assembly under pqfn area after steam
cleaning: 7.23 $\mu\text{g} / \text{in}^2$ WOA
